Fire Damper Assessment Report

Hydro-X Air

Hydro-X-Air were instructed to undertake the assessment of the installed mechanical fire/smoke dampers located in the ducted ventilation systems on site and to carry out a drop test.

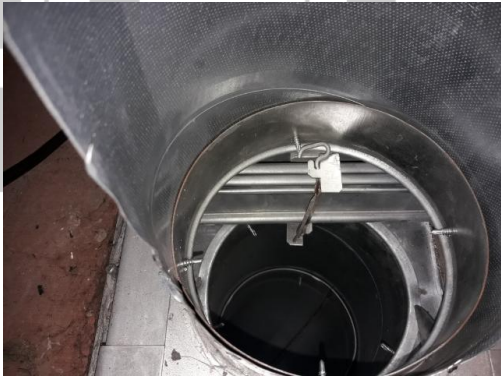
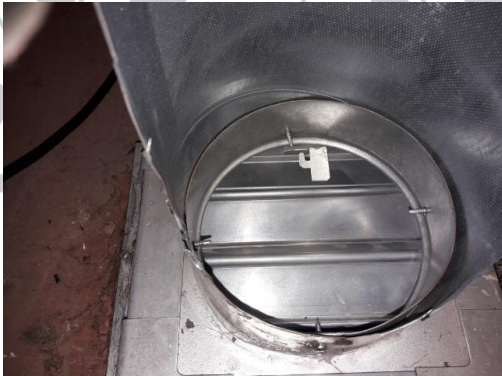
Photo of Damper as Found	Photo of Damper Drop Tested

Fire Damper ID:	1	Fire Damper Secure and Sealed in Compartment?	Yes
Location: (Building, Floor, Room)	Third Floor - plantroom 1	Accessible?	Yes
		Fusible Link Intact?	Yes
Supply / Extract?	Supply	Blades Open on Inspection?	Yes
BMS Controlled / Manual?	Manual	Is an additional access door installed on the other side?	Yes
Size (L x W or diameter mm)	150 circ	Damper Cleaned?	Yes
Time & Date?	6/11/2019 – 08:00	Drop Test Successfully Completed and Reset?	Yes

Drop test completed successfully

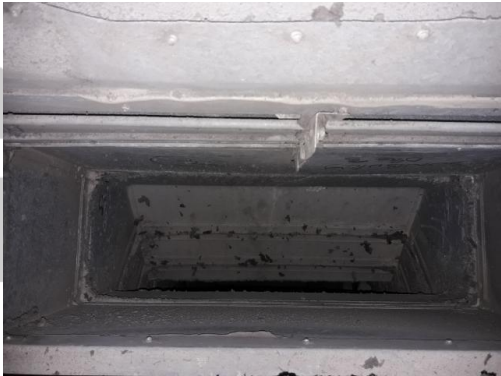
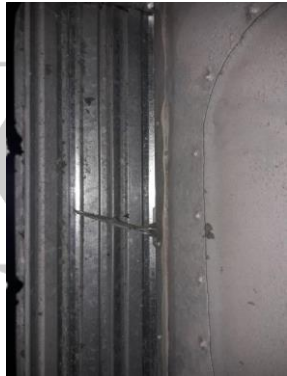
Photo of Damper as Found	Photo of Damper Drop Tested

Fire Damper ID:	2	Fire Damper Secure and Sealed in Compartment?	Yes
Location: (Building, Floor, Room)	Third Floor - plantroom 1	Accessible?	Yes
		Fusible Link Intact?	Yes
Supply / Extract?	Extract	Blades Open on Inspection?	Yes
BMS Controlled / Manual?	Manual	Is an additional access door installed on the other side?	Yes
Size (L x W or diameter mm)	400x200	Damper Cleaned?	Yes
Time & Date?	6/11/2019 – 08:47	Drop Test Successfully Completed and Reset?	Yes

Drop test completed successfully

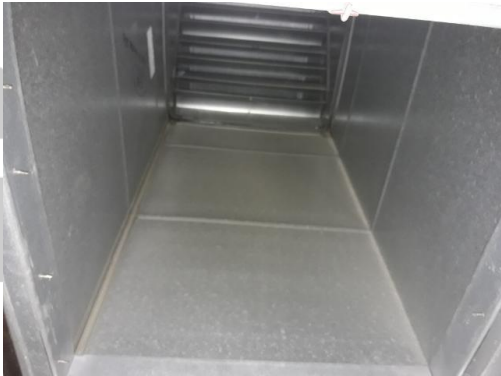
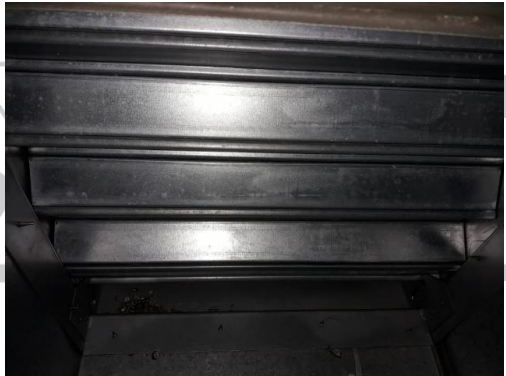
Photo of Damper as Found	Photo of Damper Drop Tested

Fire Damper ID:	4	Fire Damper Secure and Sealed in Compartment?	Yes
Location: (Building, Floor, Room)	Third Floor - plantroom 1	Accessible?	Yes
		Fusible Link Intact?	Yes
Supply / Extract?	Supply	Blades Open on Inspection?	Yes
BMS Controlled / Manual?	Manual	Is an additional access door installed on the other side?	Yes
Size (L x W or diameter mm)	400x400	Damper Cleaned?	Yes
Time & Date?	6/11/2019 – 10:34	Drop Test Successfully Completed and Reset?	Yes

Drop test completed successfully

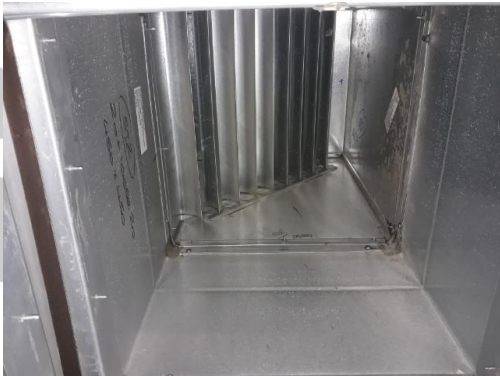
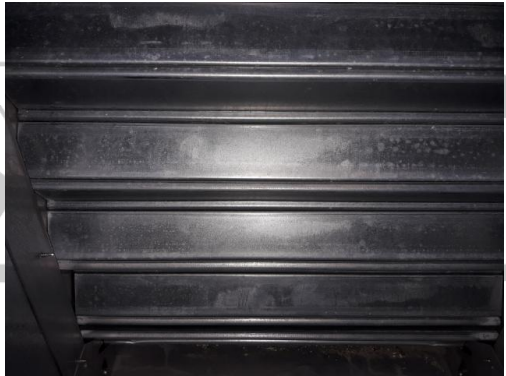
Photo of Damper as Found	Photo of Damper Drop Tested

Fire Damper ID:	6	Fire Damper Secure and Sealed in Compartment?	Yes
Location: (Building, Floor, Room)	Third Floor - plantroom 1	Accessible?	Yes
		Fusible Link Intact?	Yes
Supply / Extract?	Extract	Blades Open on Inspection?	Yes
BMS Controlled / Manual?	Manual	Is an additional access door installed on the other side?	Yes
Size (L x W or diameter mm)	400x400	Damper Cleaned?	Yes
Time & Date?	6/11/2019 – 12:09	Drop Test Successfully Completed and Reset?	Yes

Drop test completed successfully

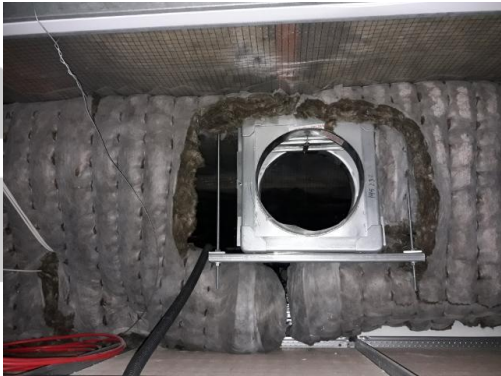
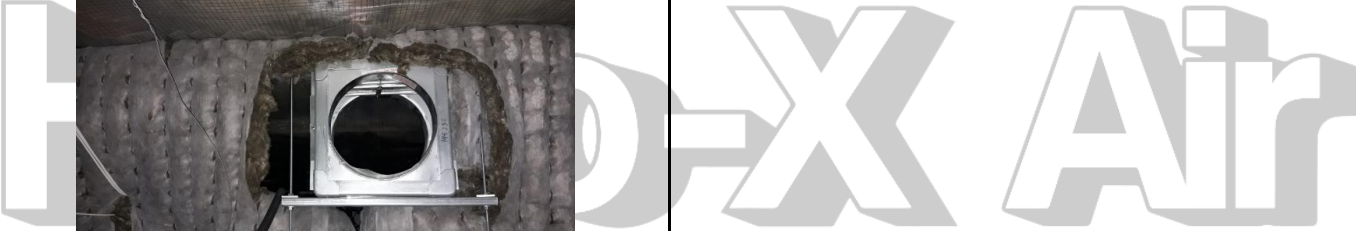
Photo of Damper as Found	Photo of Damper Drop Tested

Fire Damper ID:	10	Fire Damper Secure and Sealed in Compartment?	Yes
Location: (Building, Floor, Room)	First Floor - office	Accessible?	Yes
		Fusible Link Intact?	Yes
Supply / Extract?		Blades Open on Inspection?	Yes
BMS Controlled / Manual?	Manual	Is an additional access door installed on the other side?	N/A
Size (L x W or diameter mm)	300 circ	Damper Cleaned?	Unknown
Time & Date?	6/11/2019 – 13:50	Drop Test Successfully Completed and Reset?	No

unable to test as room was locked where I need to get access

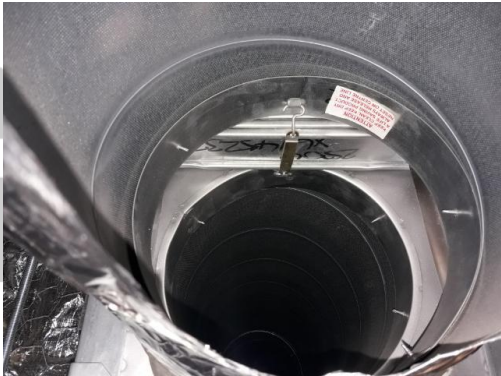
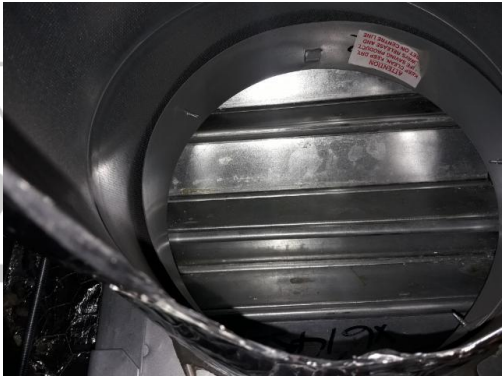
Photo of Damper as Found	Photo of Damper Drop Tested

Fire Damper ID:	12	Fire Damper Secure and Sealed in Compartment?	Yes
Location: (Building, Floor, Room)	First Floor - office	Accessible?	Yes
		Fusible Link Intact?	Yes
Supply / Extract?	Supply	Blades Open on Inspection?	Yes
BMS Controlled / Manual?	Manual	Is an additional access door installed on the other side?	Yes
Size (L x W or diameter mm)	250 circ	Damper Cleaned?	Yes
Time & Date?	6/11/2019 – 15:04	Drop Test Successfully Completed and Reset?	Yes

Drop test completed successfully

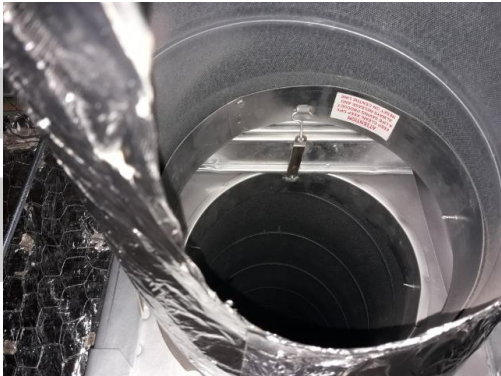
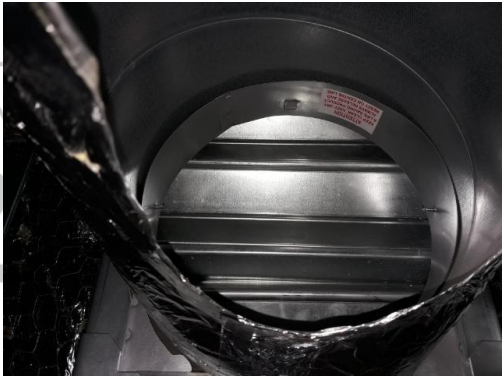
Photo of Damper as Found	Photo of Damper Drop Tested

Fire Damper ID:	13	Fire Damper Secure and Sealed in Compartment?	Yes
Location: (Building, Floor, Room)	First Floor - office	Accessible?	Yes
		Fusible Link Intact?	Yes
Supply / Extract?	Extract	Blades Open on Inspection?	Yes
BMS Controlled / Manual?	Manual	Is an additional access door installed on the other side?	Yes
Size (L x W or diameter mm)	250 circ	Damper Cleaned?	Yes
Time & Date?	6/11/2019 – 15:15	Drop Test Successfully Completed and Reset?	Yes

Drop test completed successfully

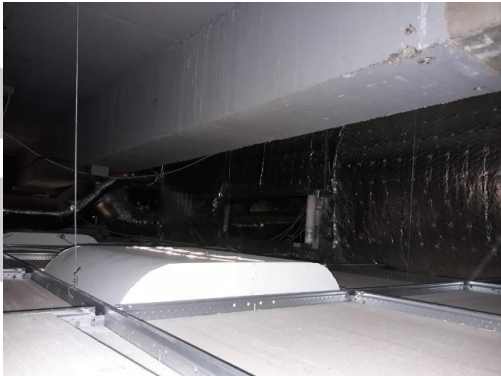
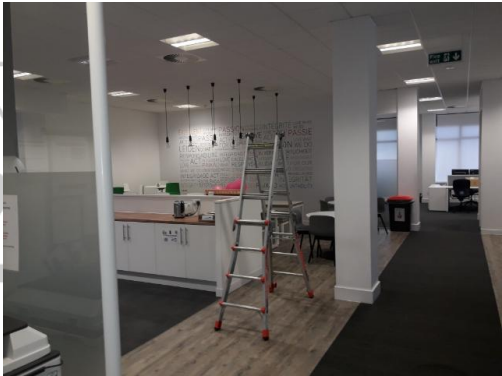
Photo of Damper as Found	Photo of Damper Drop Tested

Fire Damper ID:	15	Fire Damper Secure and Sealed in Compartment?	Yes
Location: (Building, Floor, Room)	Ash house - Ground Floor - office	Accessible?	No
		Fusible Link Intact?	Unknown
Supply / Extract?	Supply	Blades Open on Inspection?	Unknown
BMS Controlled / Manual?	Manual	Is an additional access door installed on the other side?	N/A
Size (L x W or diameter mm)	400x400	Damper Cleaned?	No
Time & Date?	6/11/2019 – 15:58	Drop Test Successfully Completed and Reset?	No

15		Ground Floor	office	The Fire Damper is not accessible.	Access should be made available to carry out drop test.

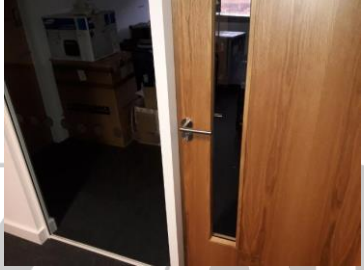
10	Room locked and unable to gain access to fire damper.

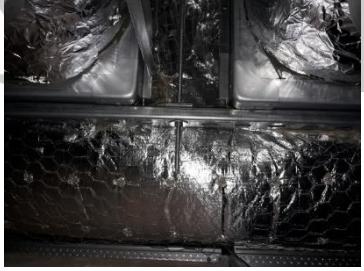
12	Unable to fit additional access door due to fire curtain

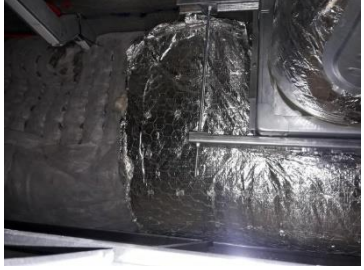
13	Unable to fit additional access door due to fire curtain

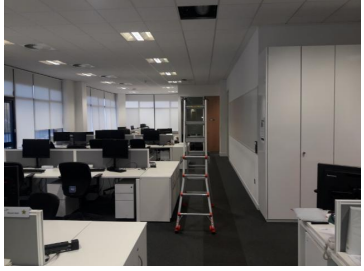
14	Mobile tower required to access fire damper safely as too high to access of a ladder

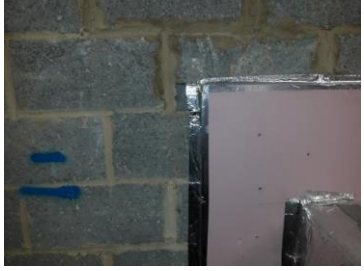
3	Unable to fit additional access door due to solid floor

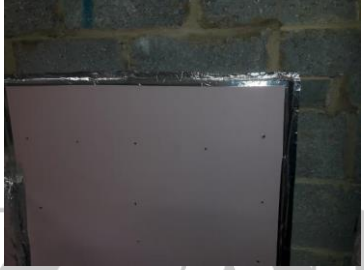
4	Unable to fit additional access door due to solid floor

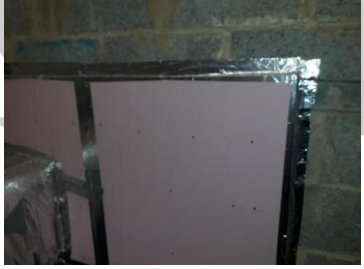
5	Unable to fit additional access door due to solid floor

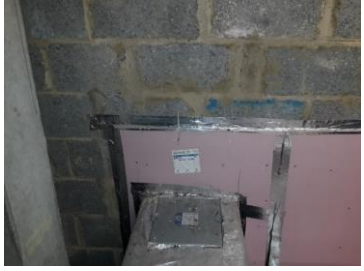
6	Unable to fit additional access door due to solid floor
